Marimba designer, Chris Banta, can tune and refinish your melodic bar percussion instruments so they'll look and sound like new.

Bar Problem Case Studies

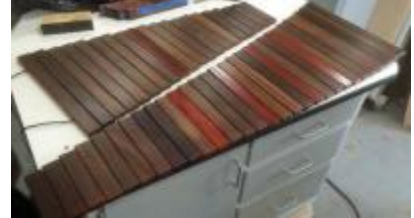
[AFTER]

A fully functional and in-tune bar set. Instrument owner was not concerned with different color of the replaced bars.

Remedy: Fabricate new replacement bars.

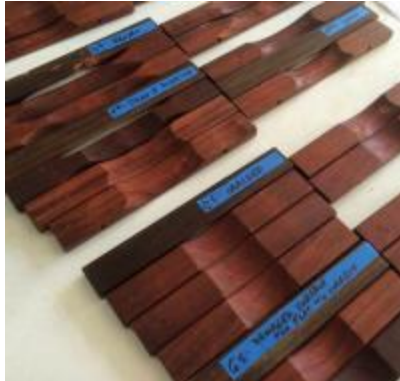
Issue: Several bars had sufficient damage leading to everything from total breakage to cracks, buzzing, to being total dead or lacking ring time.

Numerous bars had several problems making it impossible to fix by a simple re-tuning.

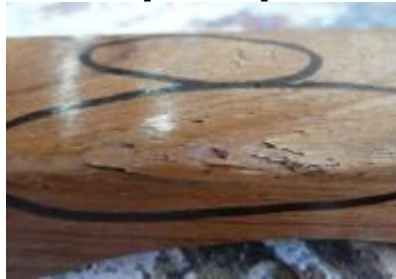
[BEFORE]

Issue: Splintering is a common occurrence in wooden xylophones. Especially in schools, xylophones tend to be exposed to the *endless glissando* scenario in which hard mallets are dragged back and forth causing the wood grain to splinter.

Corner edge of xylo bar has extreme splintering.

Remedy: Due to severe loss of sustain, a new bar was fabricated.

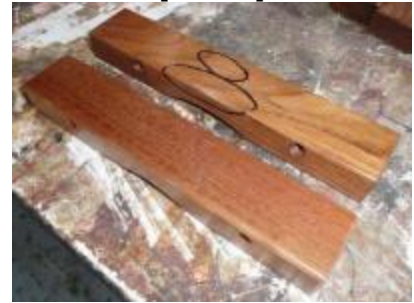
[AFTER]

The splintered bar was flat of pitch and an attempt was made to restore and sharpen its pitch. However, due to the amount of physical damage, the sustain of the bar was compromised so much that it no longer had the sustain or ring time consistent with its neighboring notes. A new replacement bar was the obvious solution.

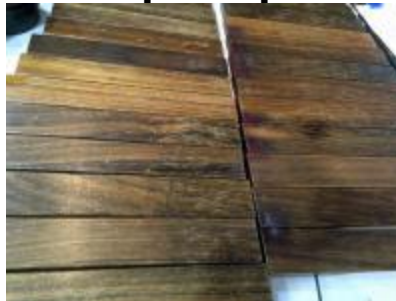
[BEFORE]

Issue: Extreme outdoor exposure to the sun had caused the bar finish of a marimba to bleach-out to an ugly gray.

Sun bleached marimba bar set.

Remedy: Top of bar surface was sanded until virgin wood was exposed.

NOTE: This was an extreme repair. So much of the top surface was removed that it greatly flattened the pitch of each bar. Although tuning was successful, a lot of additional bar material had to be removed in the pitch sharpening process. The customer was cautioned that the sanding had thinned and weakened all bars to a point where they might not hold the tune (and could easily flatten) if the marimba was played too vigorously.

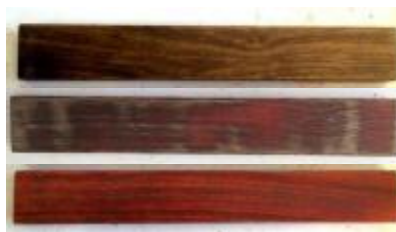
[Top] Sun-bleached surface
[Middle] During sanding
[Bottom] After Sanding

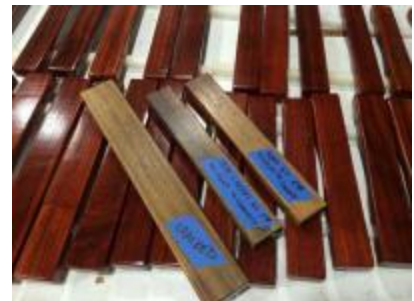
Direct comparison of before and after conditions.

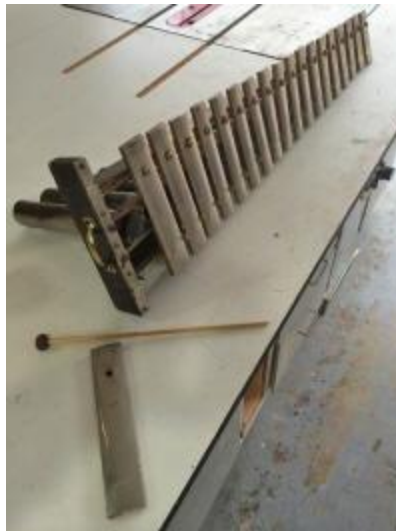
Without a proper stand, the bars could not be easily played.

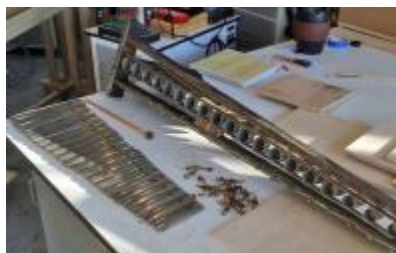
Removing the bars revealed years of deterioration on the bar rails and end caps.

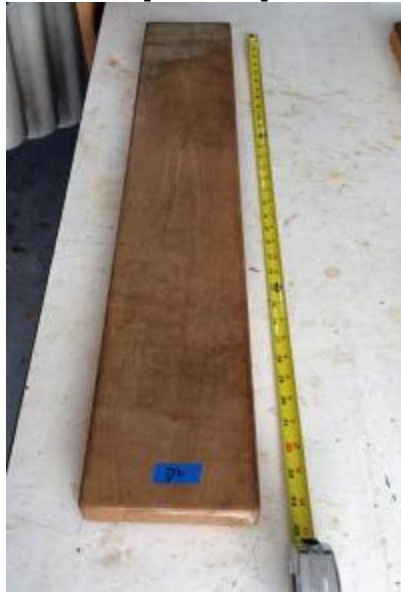
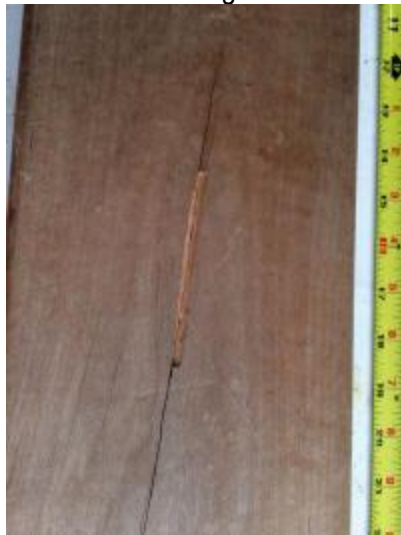
[BEFORE]

Issue: The low C2 and D2 bars on the [Masanga Marimba Band's](#) bass marimba had cracked from heavy playing due to many concerts.

Shown is a nasty crack in the low C2 Bass Marimba Bar. Bar material is hard maple, which is robust stuff when it comes to the aggressive pounding the Zimbabwean band marimbas take. The cracked bar held its pitch quite well. When disassembled all bars were checked for pitch. The C2 bar was only a few cents flat of A-440. Hard maple is amazing stuff!

Remedy: Fabricate a new C2 and D2 bars using hard maple..
